# CANADIAN FORCES FLIGHT SAFETY INVESTIGATION REPORT

## FINAL REPORT

**FILE NUMBER:** 1010-C-GEQF (DFS 2-4-2)  
**DATE OF REPORT:** 7 October 2004

**AIRCRAFT TYPE:** Katana DA-20 C1  
**DATE/TIME:** 25 June 2002 2155Z (1755 local)  
**LOCATION:** St-Lambert de Lévis (Québec City), Québec  
**CATEGORY:** "A" Category Accident

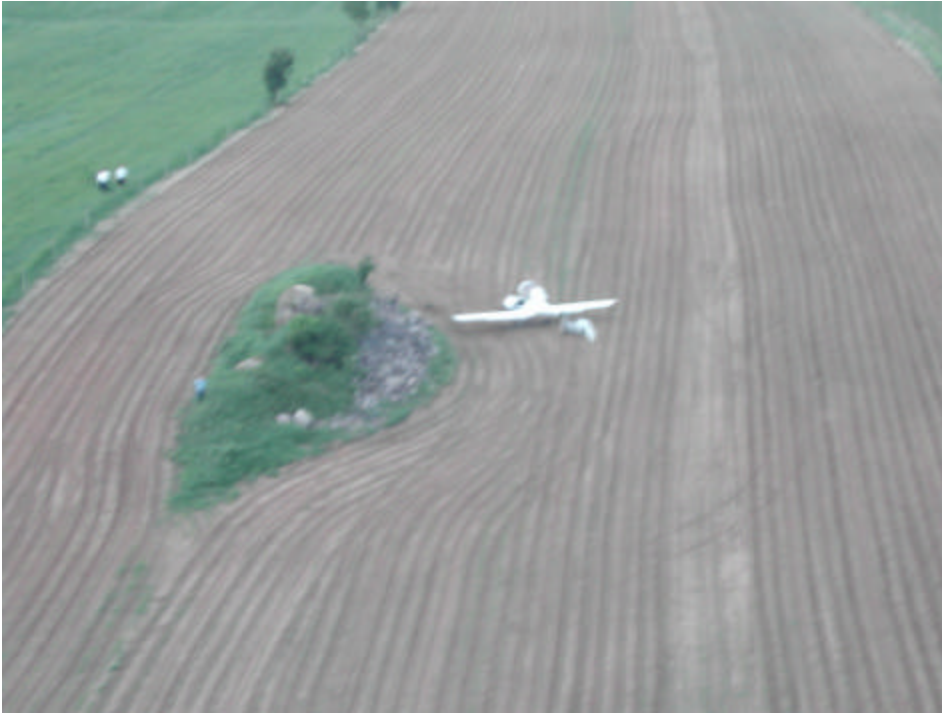
**Photo 1: Accident Site**

When the aircraft reached approximately 400' AGL, the IP took control and initiated the missed approach. While establishing the aircraft in the climb, the IP felt pressure on the flight controls such that he did not have complete control of the aircraft. He noticed that the student was pulling the control column back and to the left. While the IP attempted to avoid an aerodynamic stall by lowering the aircraft's nose and increasing airspeed, he repeatedly ordered the student to release the controls. The student did not release the controls and the aircraft, with a nose-high attitude and low airspeed, quickly lost altitude even though it was at full power. At 1755 local, the right wing contacted the ground first in a grass field adjacent to a cornfield. The aircraft then yawed 180° to the right and came to rest upright and facing backwards in the recently planted cornfield (photo 1).

The aircraft's first ground contact was by the right wing in a grass field adjacent to a cornfield. This initial contact damaged the underside of the wingtip and the main spar. It also caused the aircraft to yaw approximately 180° to the right and to land backwards in the cornfield. Although the tail boom broke and separated, the tail section remained attached to the main fuselage by the flight control cables, keeping the wreckage in one piece.

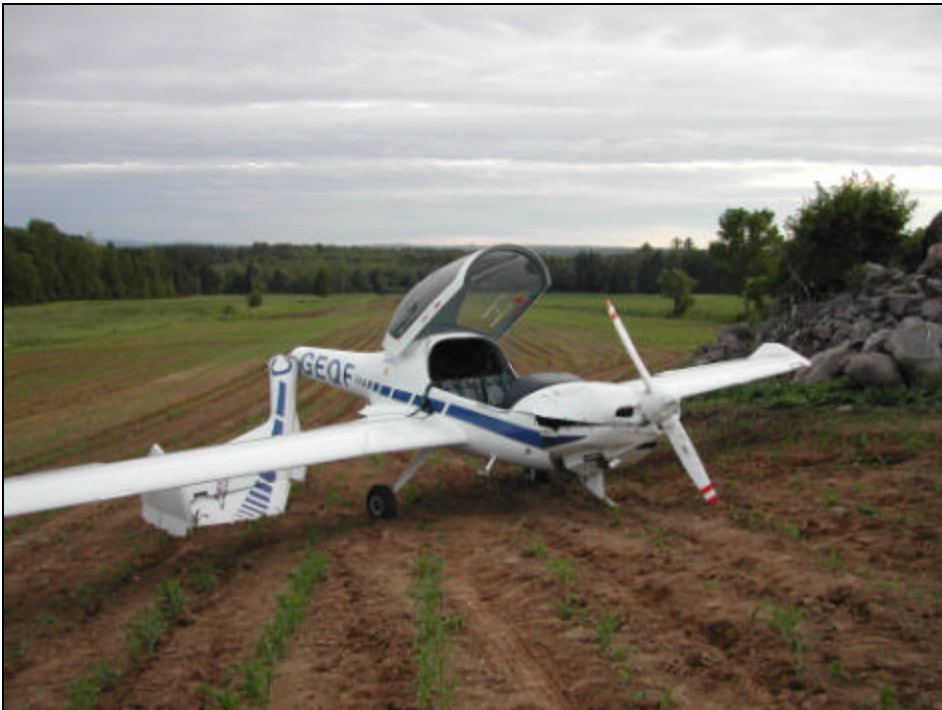
**Photo 2: Final Resting Place**

The aircraft received "A" Category damage (photo 2). The rear fuselage separated midway between the tail and the cockpit and the right wing was pushed up, damaging the spar and control rods. The nose gear separated and

the engine was forced up, damaging the engine mount. Given the extent of damage and the intricacies of composite material repair, the aircraft was deemed to be uneconomical to repair.
